Manhole Inspection Summary

Manhole # S33M1_010MH

Location Address: **217 Cherry Hill-Bridgeview** Cross Street: **Southland Ave.**

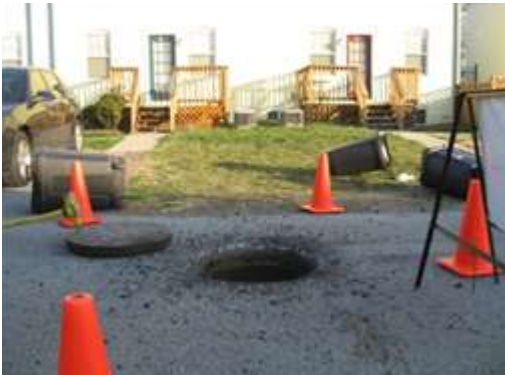
Location View

300 Cherry Hill Drive view

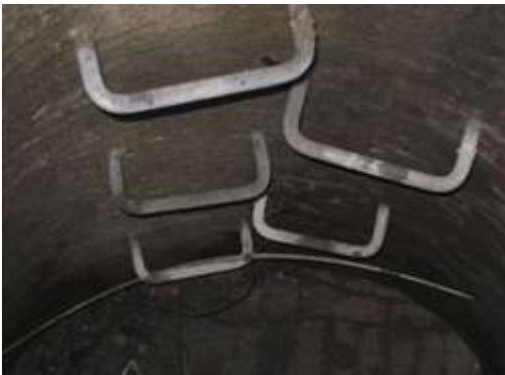
Steps Count: **5** Missing: **0** ☐ Corroded

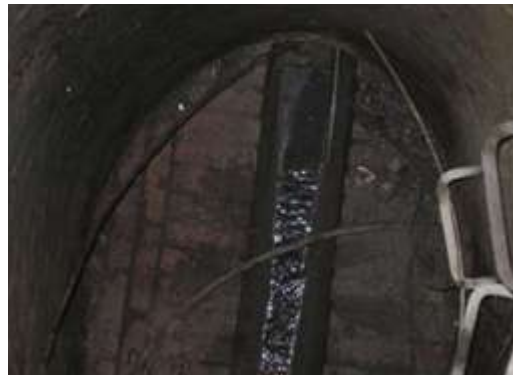
Defect 1

Foreign Objects

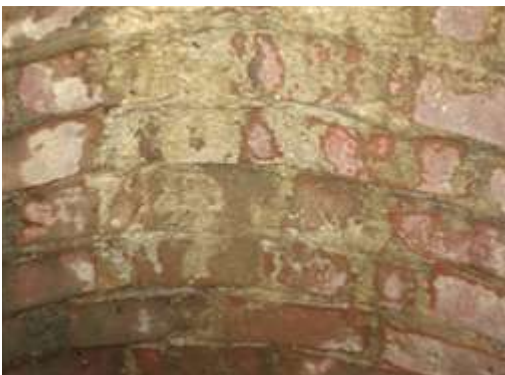
Defect 2

Corbel Material: **Brick** ☐ Parged Type: **Concentric/Eccentric**
Condition: ☒ Sound ☐ Cracked ☐ Root Intrusion ☐ Loose Brick ☐ Deteriorated
Infiltration: ☐ None ☐ Joint ☐ Cracks ☐ Mortar ☐ Roots ☒ Wall

Infiltration

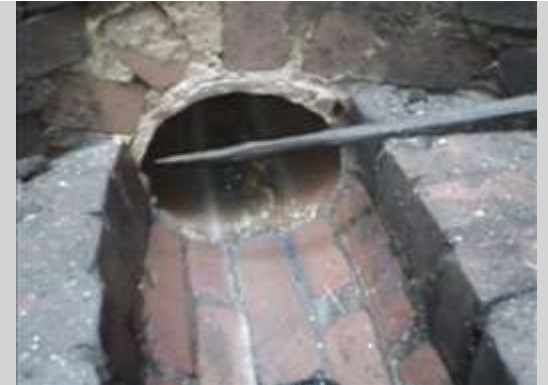
12 O'Clock Outflow

8 in. Circular Gravity Sewer
Pipe Out @ 12 O'Clock

Pipe Height: **9.6** (in.) Rod and Bar (Angled)

Pipe Material: **Clay** ☐ Pipe Lined

Invert Depth: **10.55** (ft.) Flow Characteristics: **Fast**

Infiltration: **None** Pipe Seal Cond: **Sound**

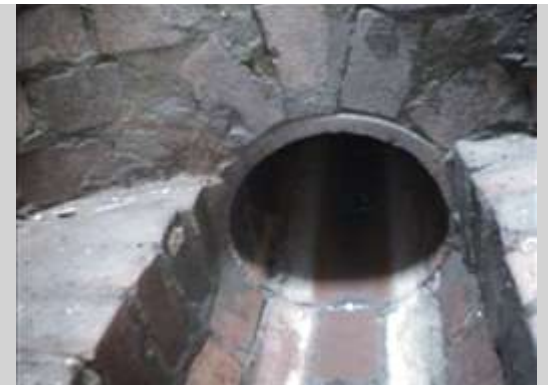
6 O'Clock Inflow

8 in. Circular Gravity Sewer
Pipe In @ 6 O'Clock

Pipe Height: **9.6** (in.) Rod and Bar (Angled)

Pipe Material: **Clay** ☐ Pipe Lined

Invert Depth: **10.41** (ft.) Flow Characteristics: **Fast**

Infiltration: **None** Pipe Seal Cond: **Sound**
